**Technical Audit
of
Wheel Pressing Procedure
for
Electric Locomotives**

Report No.: RDSO/2016/EL/TAR/0007 Rev. '0'

Issue Date: 03.06.2016

Issued by
Electrical Directorate
Research, Designs and Standards Organisation
Manak Nagar, Lucknow-226011

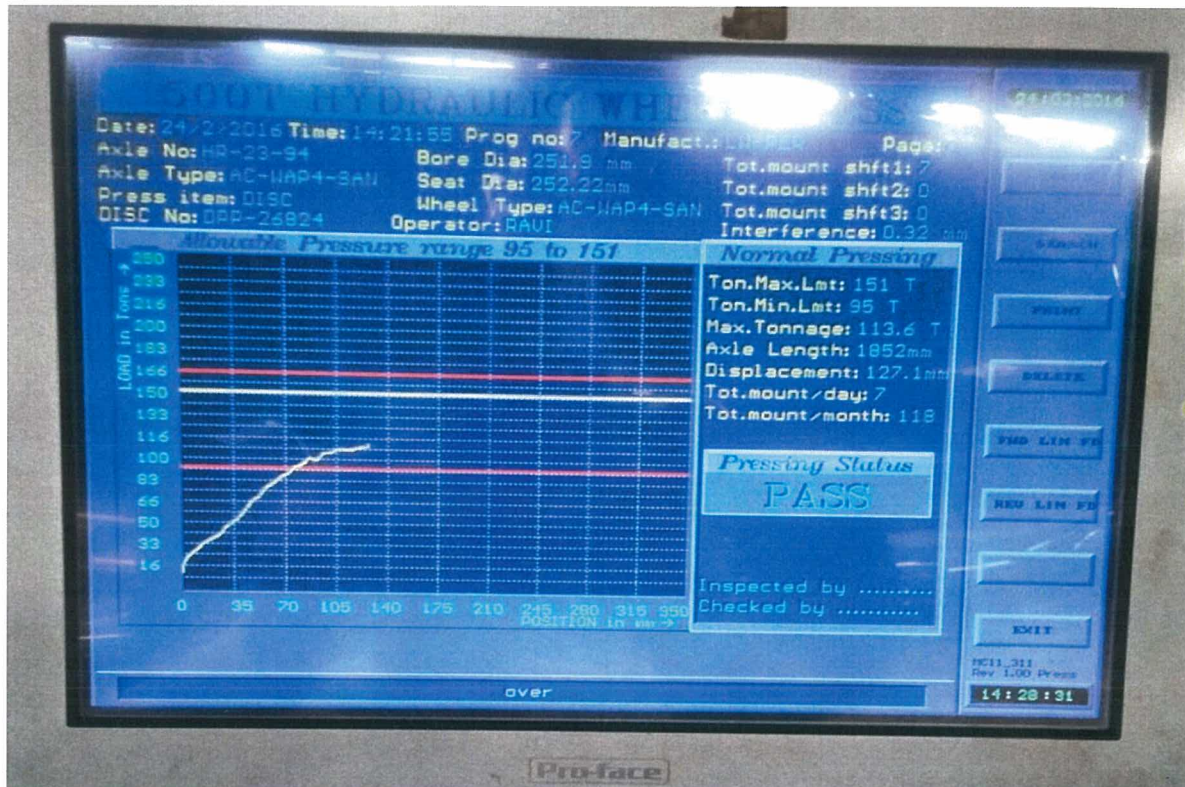
Fig 3 : Automatic recorder for pressing-in force vs displacement

- 2.8. The pressing-in force as a function of displacement should be recorded using automatic recorder:-

- 4.9.4. The final pressing-in pressure should lie between the stipulated pressing-in pressure as per the relevant drawing.
- 4.9.5. This plot should be inspected and compared with the reference plots given in technical circular to arrive at a decision regarding correctness of wheel pressing instead of merely looking at the "PASS" or "FAIL" reported by the machine.

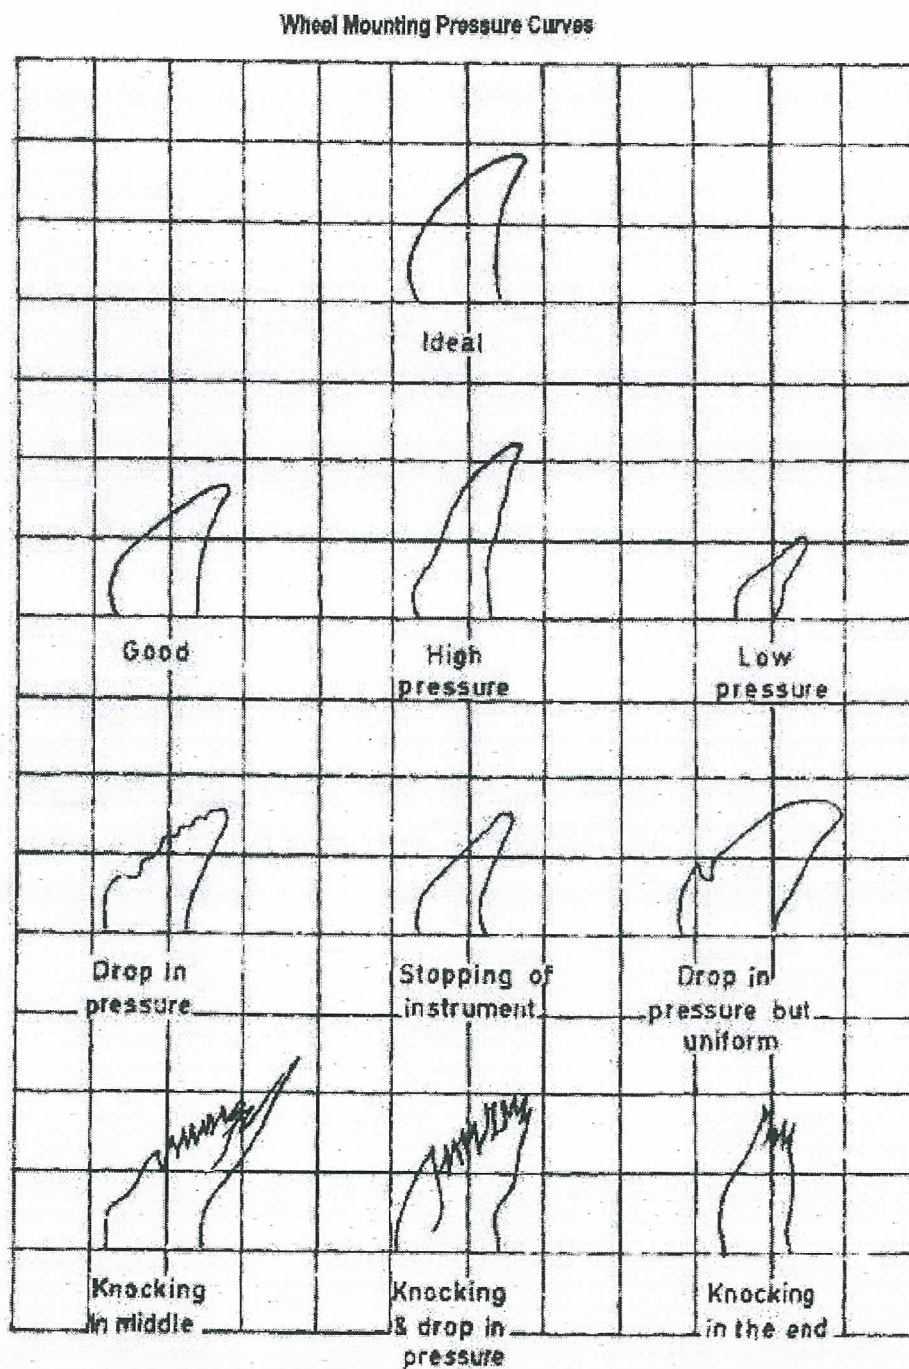
Fig 4. Sample Pressure vs Displacement Graphs

The resultant graph should be similar to ideal/good graph as shown below:-

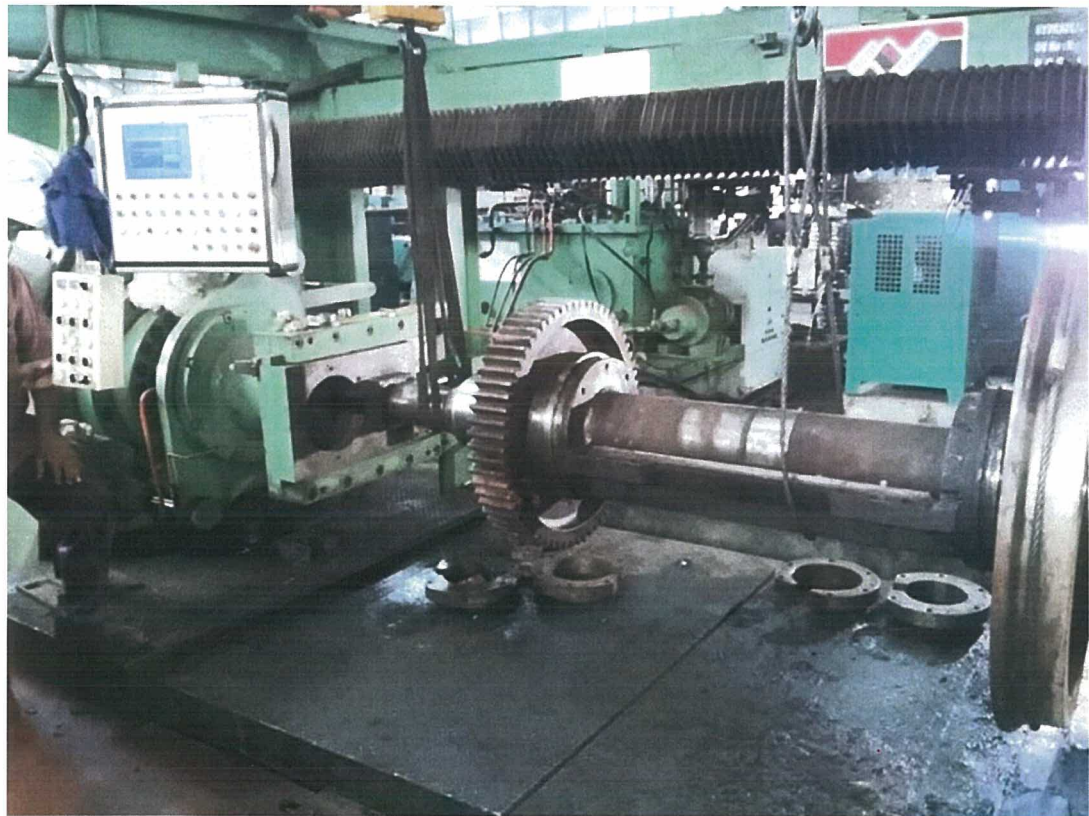
Fig 6 : Wheel disc pressing (Non-Gear Side)

- 3.6. All the workshops are measuring wheel seat diameter of axle and wheel bore diameter and are maintaining prescribed interference. However, the pressing-in pressure varied from 95-151T as opposed to 95T to 132T. This has now been adjusted to 95T to 132T after being pointed out at the time of technical audit.
