Technical Audit Report

Maintenance/Manufacturing Process of Elastic Ring

Report No.: RDSO/2018/EL/TAR/0015 Rev. '0'

Technical Audit at CLW/CRJ**Date: 09.11.2017****1. INTRODUCTION:**

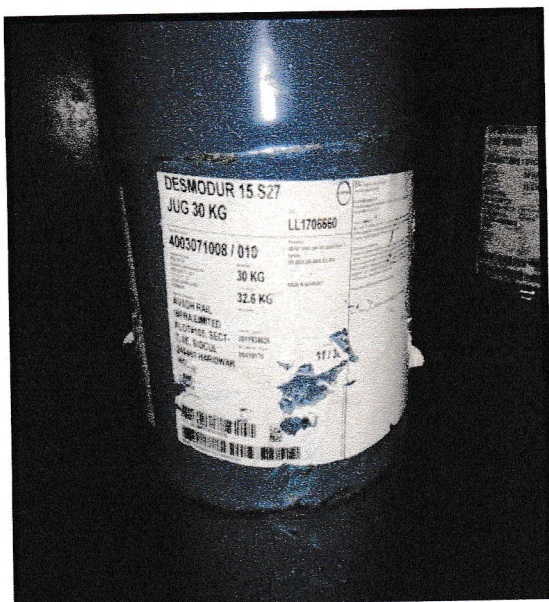
Firm is obtaining raw material and technology for reputed source i.e. Covestro/Germany Spin off of Bayer/Germany. Raw material drum are shown in Figure 1 & 2 for ready reference. Therefore, it is concluded that raw material used is of proper quality.

Fig.1- RAW MATERIAL(DESMODUR)

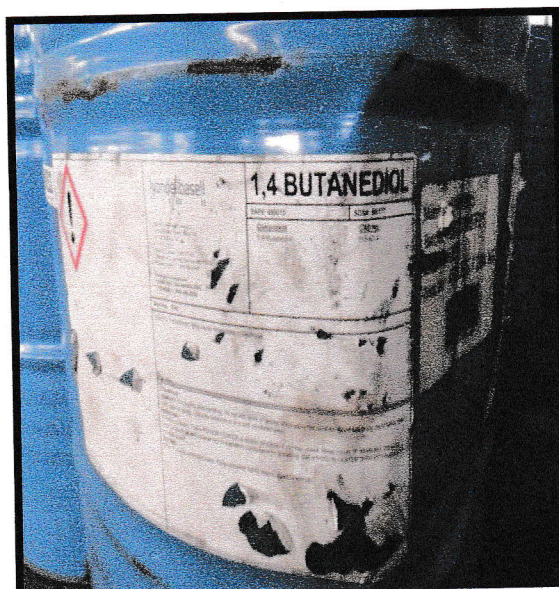
Fig.2- RAW MATERIAL(BUTANEDOIL)

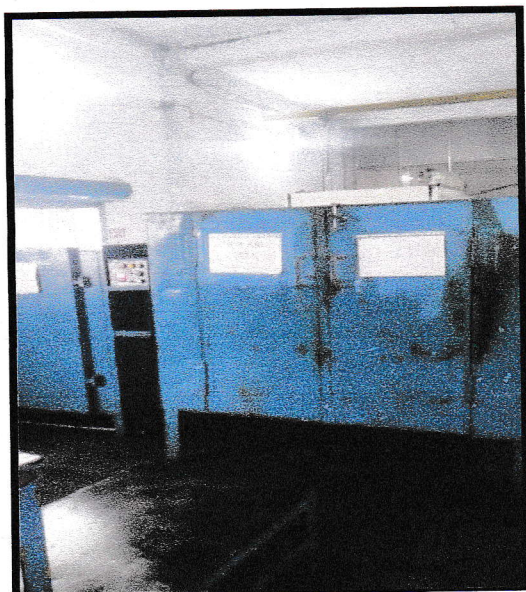
Fig.3-HOT AIR OVEN
Range: 0 to 250°C
Make: Prolific

Various manufacturing processes as described in flow chart are indicated in figure-3 to figure-7 for ready reference. From the above it is found that manufacturing process is in order.

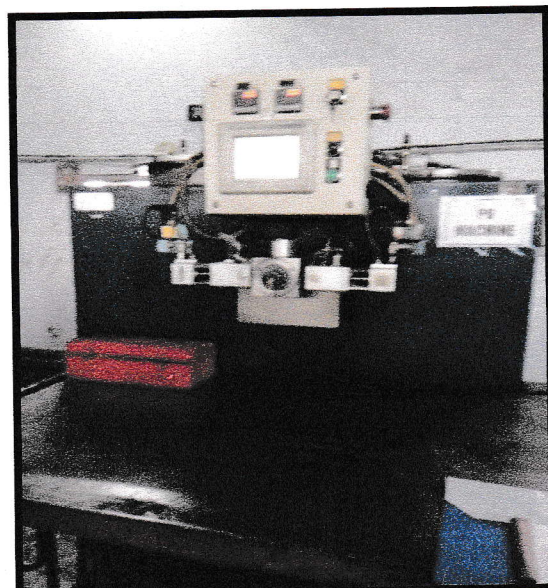
Fig.4- PU(POURING) MACHINE

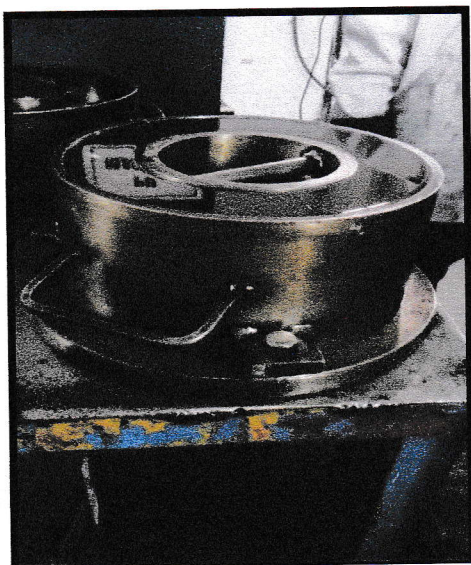
Fig.5-RING MOLD

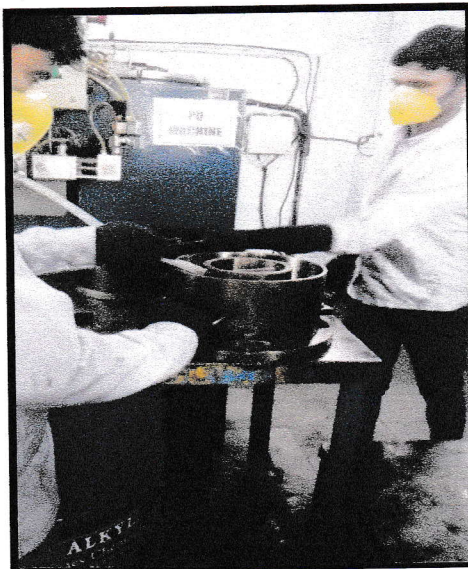
Fig.6-FILLING PROCESS

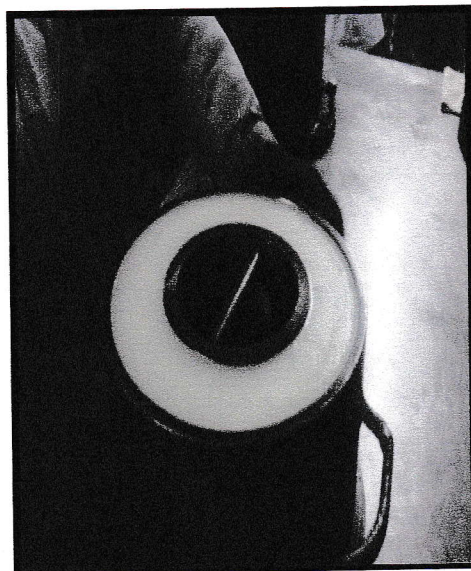
Fig.7-FILLED MOLD

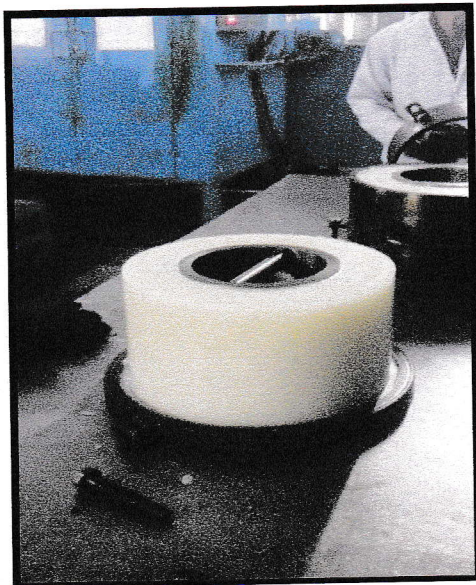
Fig.8- DE-MOLDING OF RING

From the above, it is observed that the firm has corrected its curing process as per the requirement.

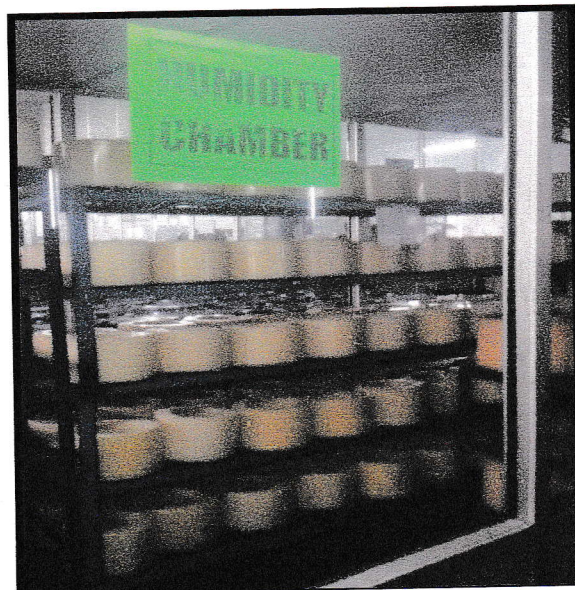
As per the guidelines of the M/s Covestro (attached as attachment-1), now complete curing and maturation is being done in 35 days. Maturation of ring is being ensured by the filled format attached at attachment-2. RDSO has suggested some changes in the format. Suggested format is attached as attachment-3.

Fig.9-HUMIDITY CHAMBER FOR MATURATION

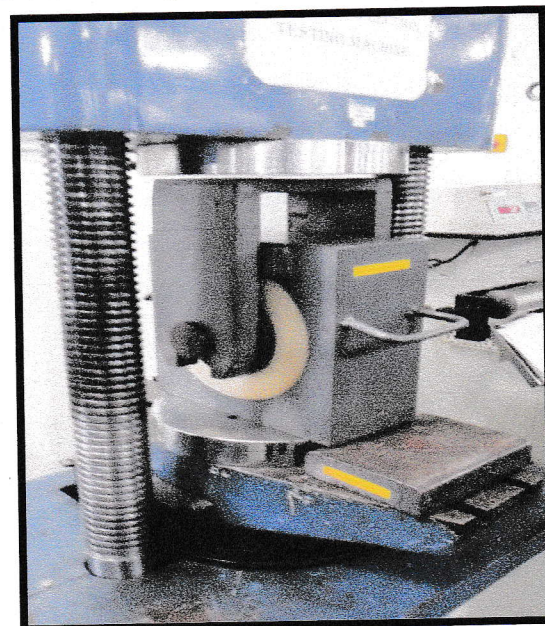
Found proper lighting and cleanliness in the works premises. Following routine tests on one fresh sample developed by the firm was conducted. The details are given below:-

Fig.10-LOAD DEFLECTION TEST
Range: 0-1000kN
