Government of India - Ministry of Railways
Research, Designs & Standards Organization,
LUCKNOW – 226011
Fax: 91 - 0522 - 2452581
Tel: 2465714/ 2450374

No. EL/11.5.5/5

Sub: Minutes of the Meeting on reliability of GTO and IGBT based traction converter (SR) auxiliary converter (BUR) and vehicle control unit (VCU) in three phase electric locomotives.

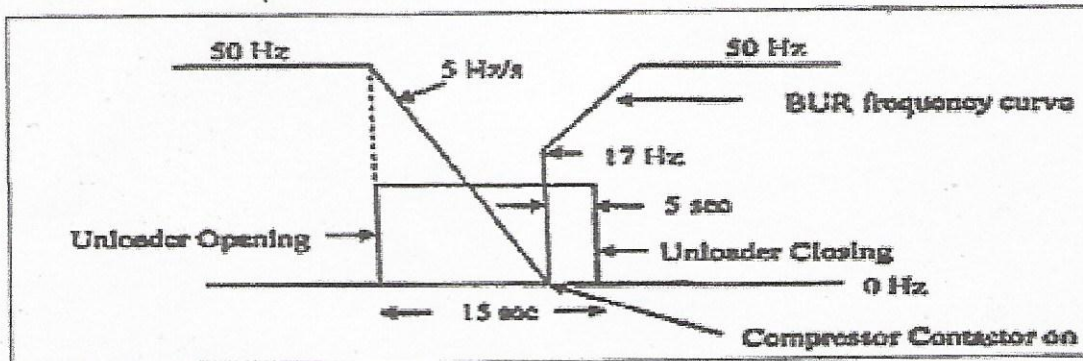
Fig: Schematic of BR ramp up/ramp down timings

Railways have reported about non-standard timing of ramp up/ramp down in BUR which creates of lot of confusion and issue of generation of unwanted signal. In this

regards all converter manufacturers are advised to implement the ramp up/ramp down time as given below which has been successful implemented in MICAS based loco.
